DECK REPAIR WITH
VOID TUBE REPLACEMENT

REPAIRING CONCRETE DECK (HALF-SOLING)

COUNTY VSR01

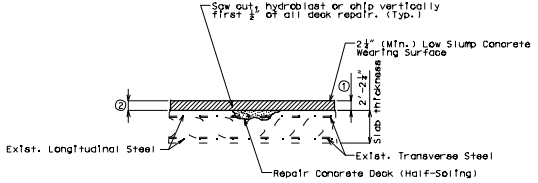
SUPERSTRUCTURE REPAIR (UNFORMED)

① 2¼" (min.) Low Slump Concrete Wearing Surface ② Existing 2" Low Slump Concrete Wearing Surface
